NASA TN D-7968

**APOLLO EXPERIENCE REPORT -
FLIGHT ANOMALY RESOLUTION**

John D. Lobb

FLIGHT ANOMALY RESOLUTION

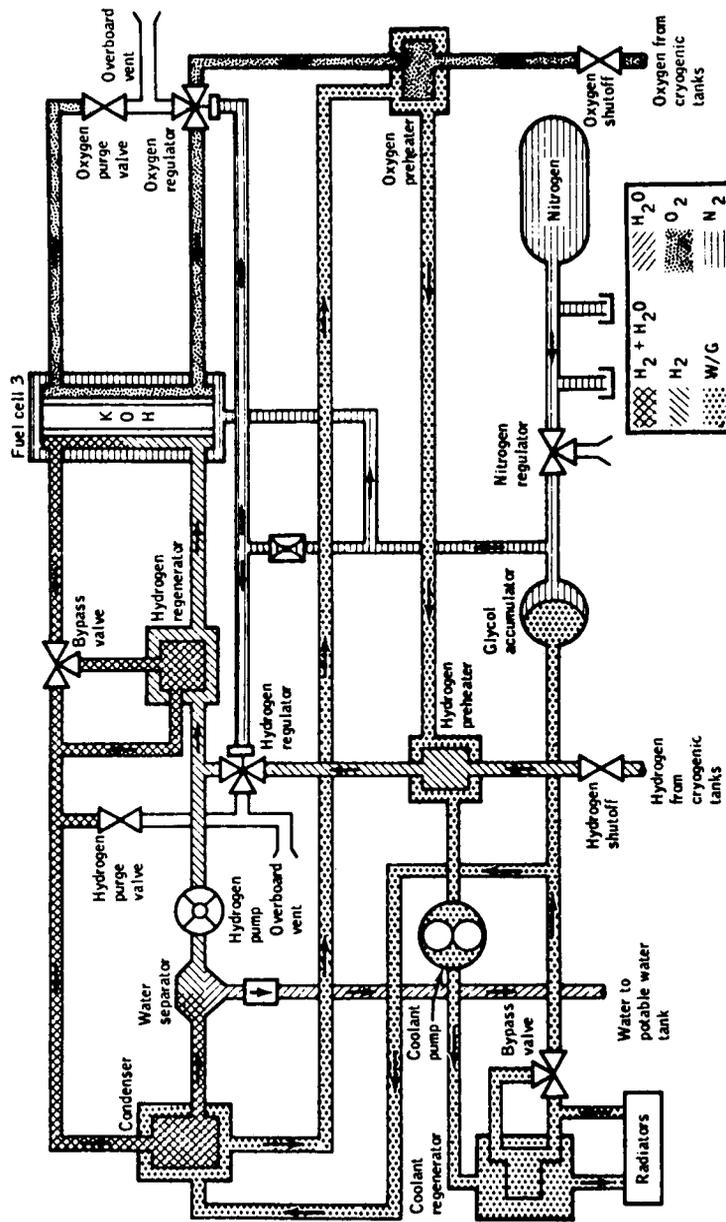
Figure 3.- Fuel cell schematic.

a. Apollo 11 data indicate the secondary bypass valve (fig. 3) did not move as a result of the periodic disturbance; this observation is based on the slow recovery time (on the order of 4 minutes) for condenser exit temperature following each disturbance. If the valve had moved, full recovery should have taken place in a matter of seconds. The Block II retrofit secondary coolant bypass valve (Block I valve poppet) may have contributed to this behavior; however, the valve characteristics do not support this conclusion, since the response times of the two valves (Block II and Block II retrofit) are virtually the same for a condenser exit temperature disturbance of the type experienced in flight.

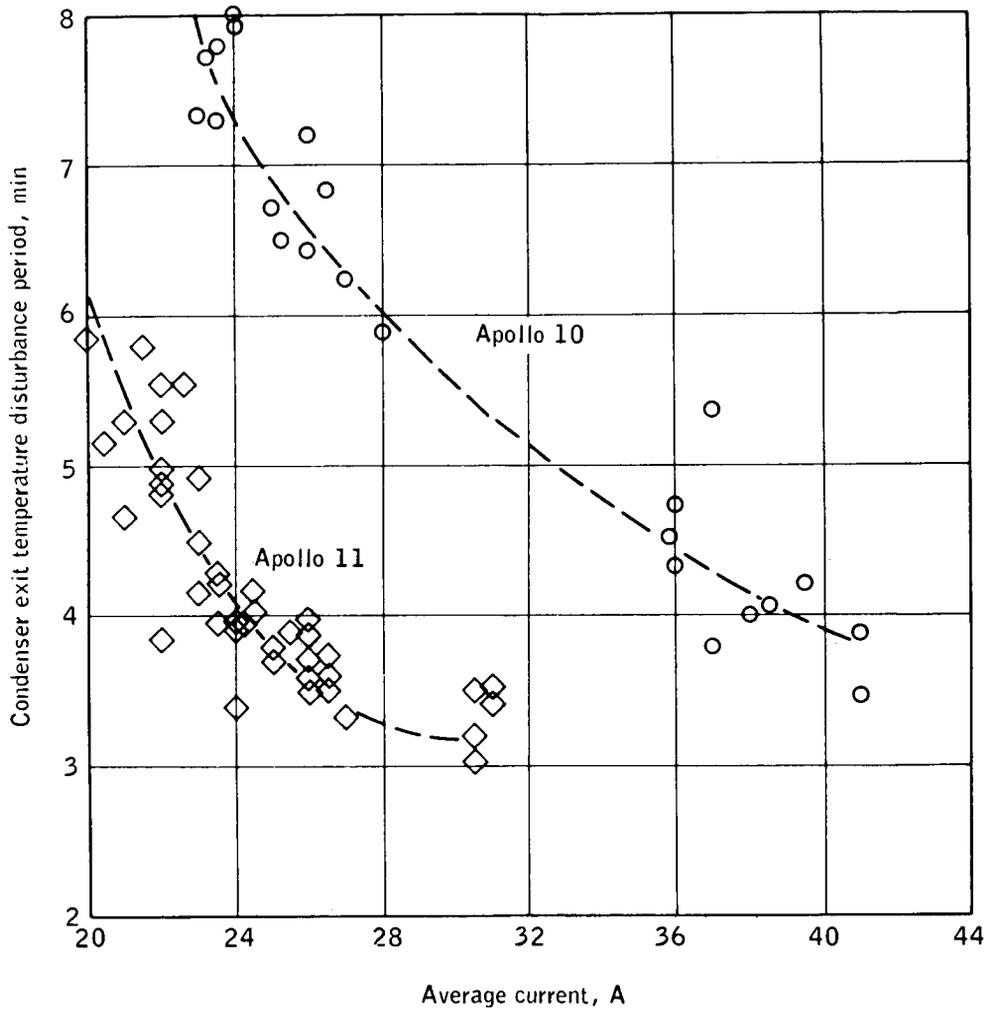
Figure 4.- Load-period relationship.

h. Apollo 10 and 11 data show a definite relationship between the frequency of the disturbance and the electrical load on the affected fuel cell (fig. 4).
